Safety Countermeasure of Onagawa NPS after the Great East-Japan Earthquake and Tsunami

March 6, 2014 at City University of Hong Kong
 March 7, 2014 at Nuclear Society Seminar of Hong Kong

➤ Akiyoshi Obonai
 ➤ Takao Watanabe
 Tohoku Electric Power Company

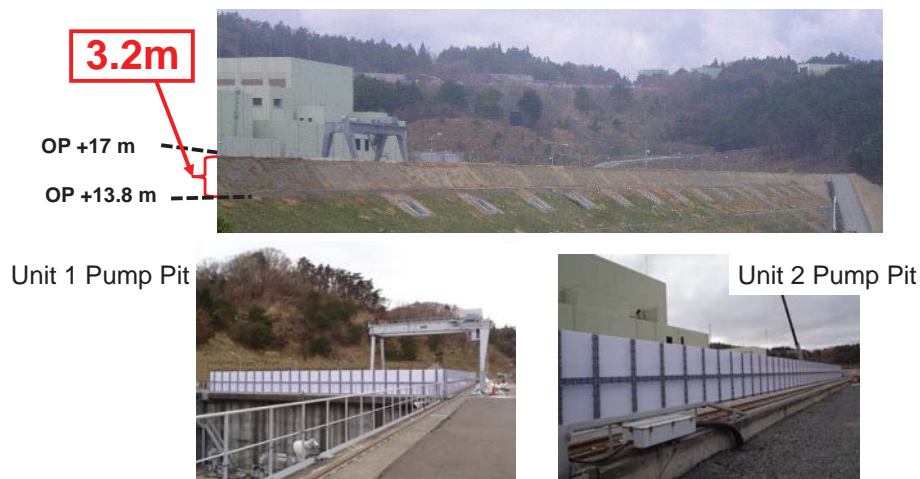
Immediate Upgrade : Additional Seawalls

* subsidence

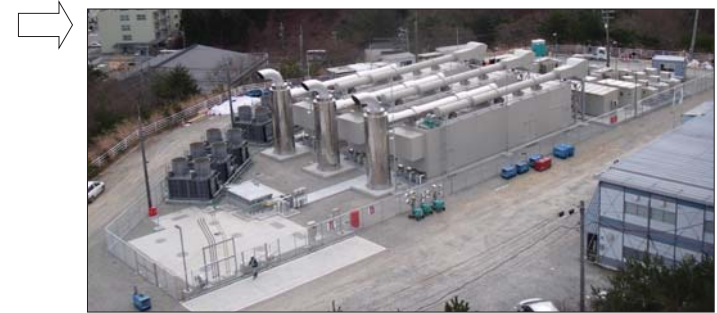
Immediate Upgrade : Enhance Electric Power Supply (1)

- Step1: Movable Power-Supply Car
- Rate Output: 400kVA X 4 units
 - Deploy on a ground at 22m above sea level

- Step2: Installation of Air-cooled Diesel Generator
- Rate Output:5,000kVA X3 units
 - Set up on a small hill at 52m above sea level

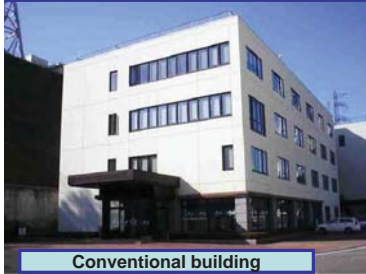
Former administration building

Conventional building

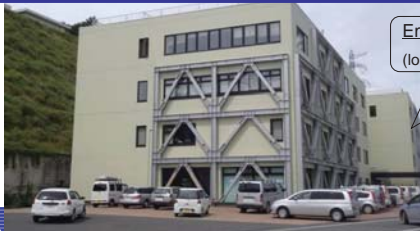
Seismic reinforcement with brace
(July 2009 ~ March 2010)

Emergency Response Room
(located on the third floor)

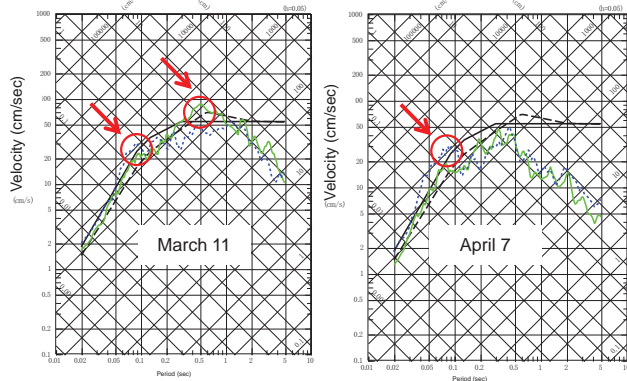
Reevaluate the design basis seismic ground motion (DBSGM)

Observed Earthquake Response Spectrum: **North-South Direction**
East-West Direction

We found:
the value of the observed earthquake spectrum exceeded that of the design basis seismic ground motion in a short period

We decided to set up new "Design Basis Seismic Ground Motion"

— Design Earthquake Motion Ss-D (Horizontal)
(Earthquake ground motion with the site specific earthquake source locations)
..... Design Earthquake Motion Ss-B (Horizontal)
(Earthquake ground motion with no such specific source locations)

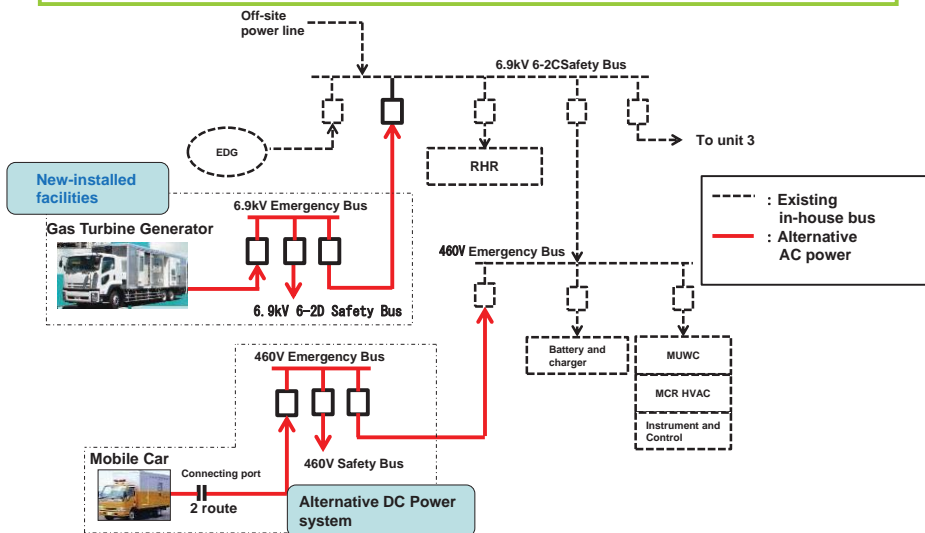
Alternative power supply system

◆ Configuration of alternative power supply system

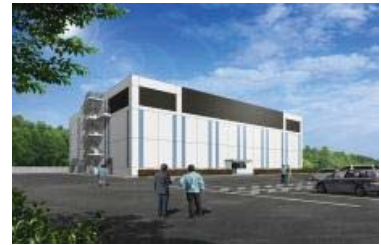
Artist Rendition of Emergency Response Center once completed

Fortify ERC furthermore for sever accident

- Seismic-isolation building
- Thick skeleton for radiation shielding
- (Less than 100mSv/7days when SA occurred)
- Diverse communication tool
- Exclusive diesel generator
